**ANALISIS PENYEBAB BANJIR PADA JALAN RAYA DI KOTA  
PALEMBANG (STUDI KASUS : JL. URIP SUMAHARJO  
LRG.LANGGAR AJENDAM II SRIWIJAYA)**

**Analysis of Causes of Flooding on Highways in Palembang City  
(Case Study: Jl. Urip Sumaharjo Lrg. Langgar Ajendam II Sriwijaya)**

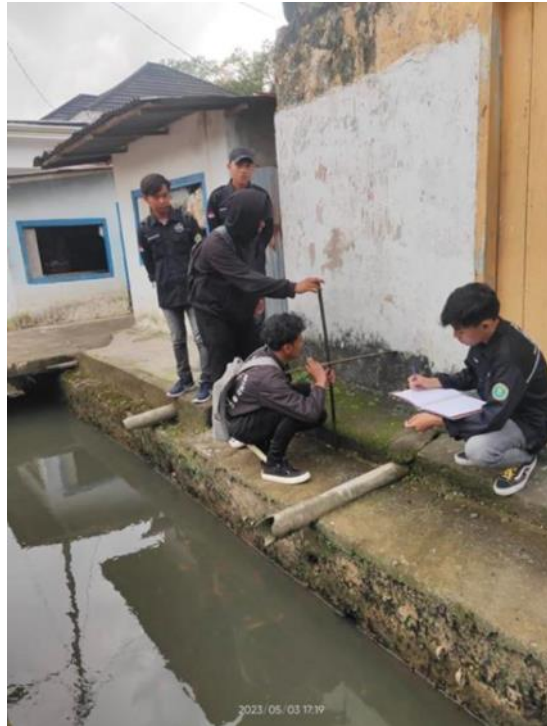
Figure 3.2 Measuring Channel Width

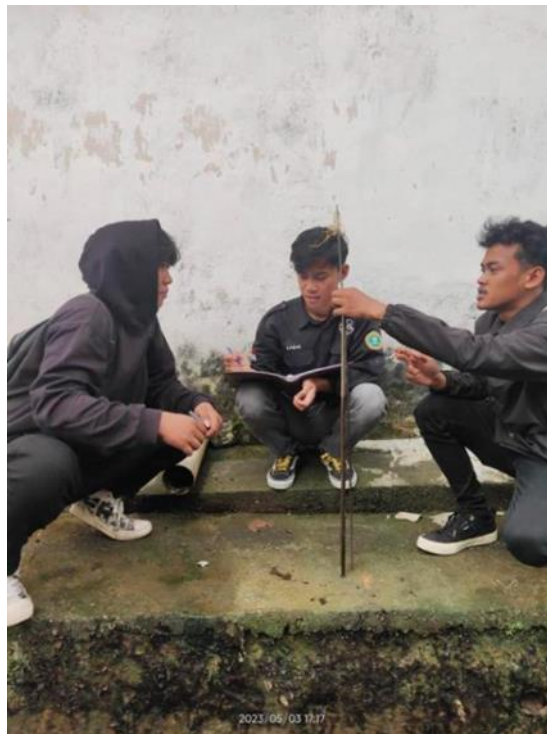
Figure 3.3 Measuring Drainage Height

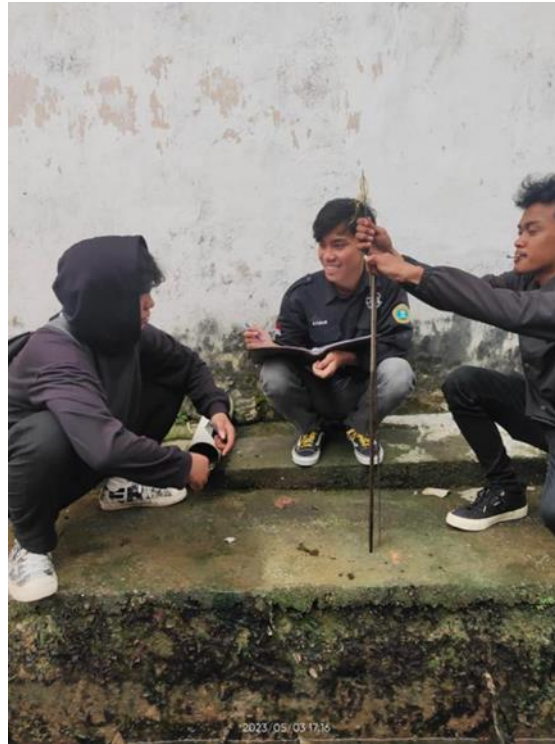
Figure 3.4 Measuring Sedimentation

- There is no filter in the drainage channel so that waste flows directly with the current.
- Lack of maintenance so that the moss is too thick around the drainage and also makes the drainage slippery so that when we surveyed someone fell.
- High sediment levels in the Drainage so that when it rains the channel does not hold water well and causes flooding or quickly overflows onto the road.

1. Make improvements to drainage channels
2. Dredging the sedimentation so that the volume of water in the sedimentation will not increase or excess.
3. Conduct regular maintenance

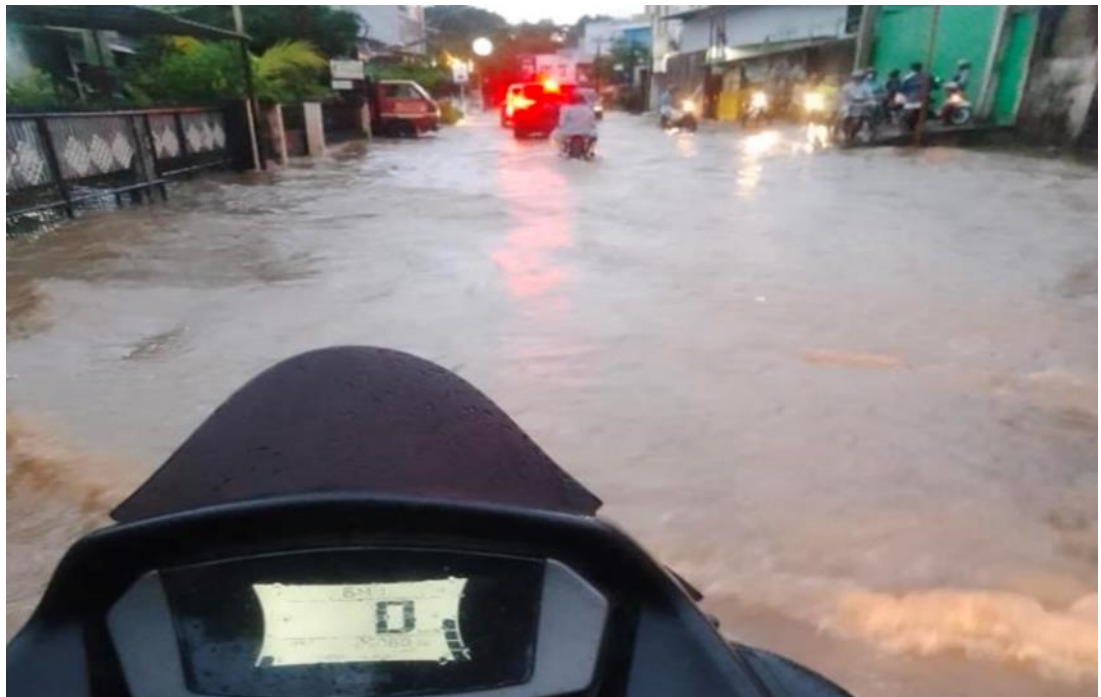
With topographical conditions and the result of this problem is thick sediment resulting in rainwater overflow and flooding, puddles, and other negative impacts on the environment and infrastructure in the area.

Figure 3.6 photo of Ajendam II/Sriwijaya road affected by flooding.

4. Making infiltration wells. Infiltration wells are one of the water conservation engineering techniques in the form of buildings made in such a way as to resemble the shape of a dug well with a certain depth that serves as a place to collect rainwater that falls on the roof of a house or impermeable area and infiltrate it into the ground.
